Manatū Taonga Ministry of Culture & Heritage National War Museum - Carillon Tower

Concept Strengthening Report

Revision 1.0.0
22 November 2022
144373.13

National War Museum - Carillon Tower

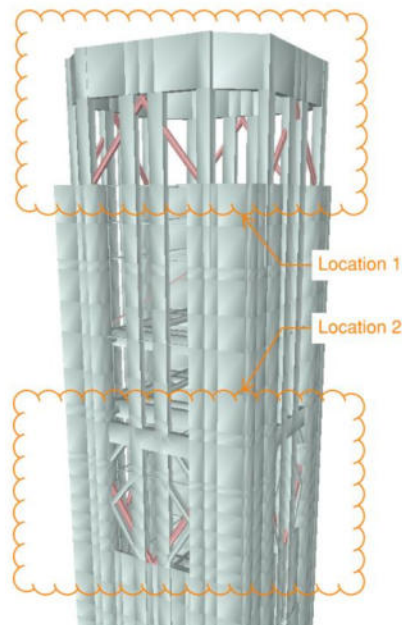
Figure 7: Locations subjected to deformation incompatibility issues (Carillon Tower)

Notably, the building appears to be subjected to deformation incompatibilities: a phenomenon which occurs when tied together structural elements want to deform differently due to the different stiffness properties of the structural system. This drives large local forces through the structure. Locations where this is primarily noted is highlighted in Figure 7. Various described structural weaknesses are found in these highlighted areas.

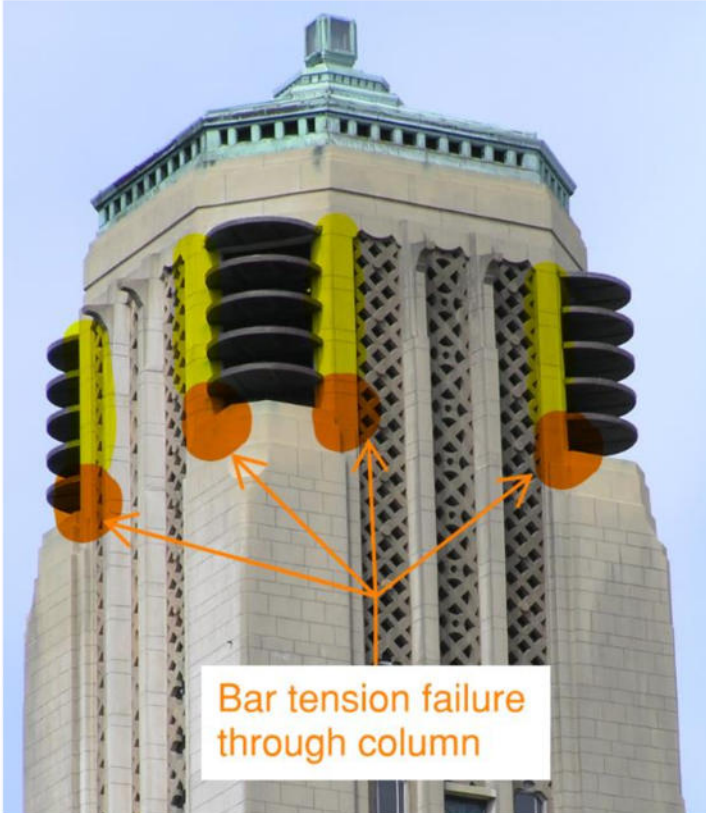
Element	%NBS	Description of Weakness
Level 7b- L8 reinforced concrete corner columns	NBS rating: NBS = 34% (IL3)	<p>Bar failure under tension action on column.</p>

<p>Bar tension failure through column</p>

The results of the seismic assessment of the tower indicate the building's seismic rating to be 34%NBS (IL3), governed by the upper reinforced concrete columns within the tower (base of level 7b, upper catwalk). The columns undergo a ductile failure mechanism in which the reinforcing bars within the columns yield under excessive tensile action. At early onset failure, seismic load is expected to be spread between the different reinforced concrete columns and steel bracing, which adds resilience to the load path of the top structure (level 7b and above). Failure of the described combined system may cause collapse of the top structure, which could present a significant life safety hazard to people in and around the building. However, this failure is localised to the top of the structure and is not expected to cause global failure of the tower in a seismic event.

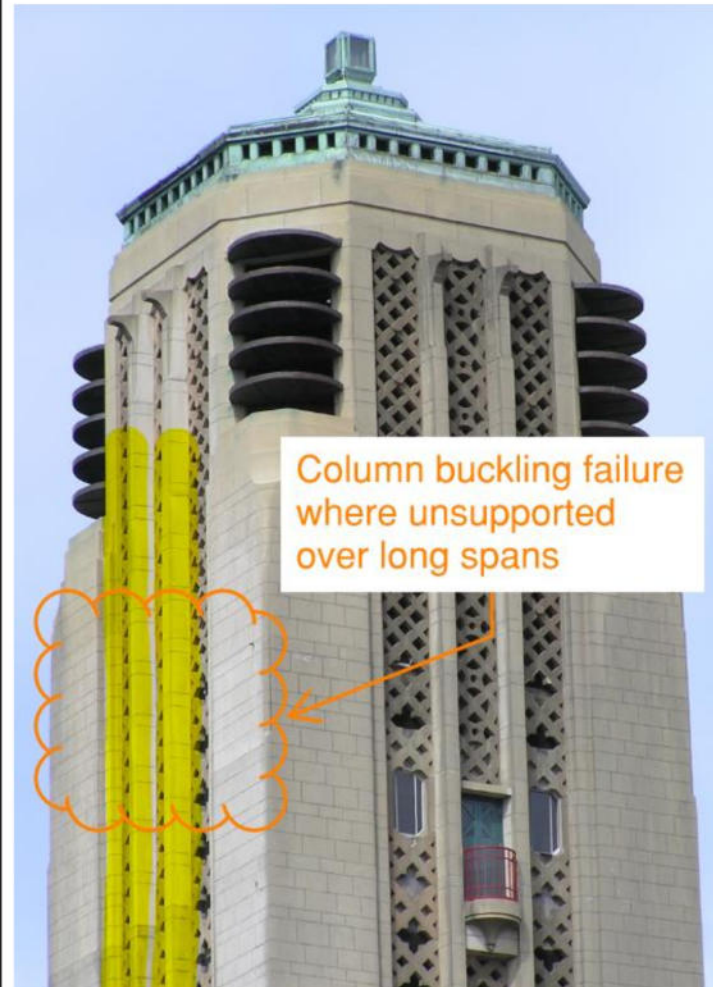
Reinforced concrete column at locations of long unsupported spans

NBS rating: NBS = 35% (IL3)

Buckling failure (combination of compression and bending). Column unsupported laterally over long spans.

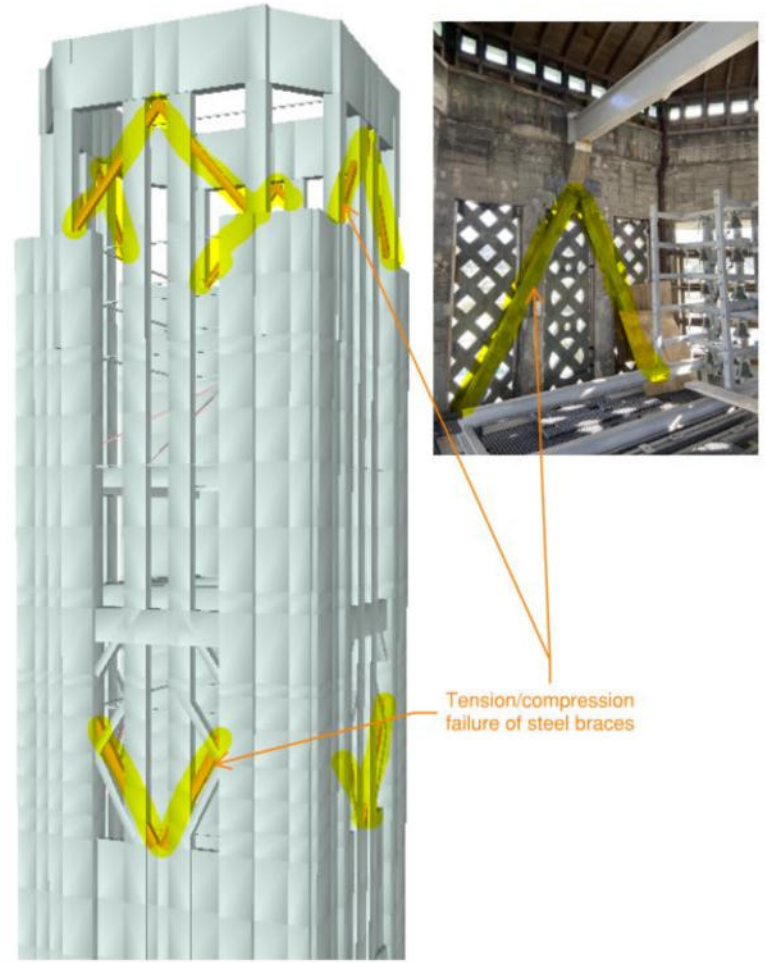
Top (200PFC) and bottom (250PFC) steel braces

NBS rating: NBS = 40% (bottom braces), 60% (top braces) (IL3)

Tension/compression failure of steel braces.

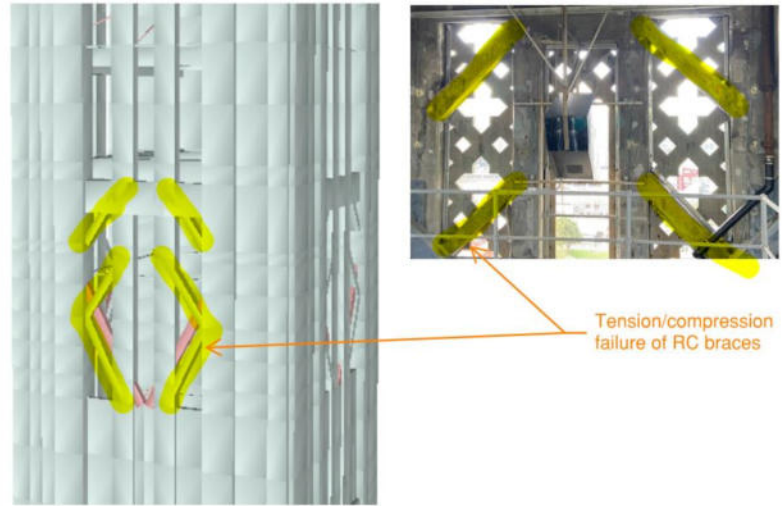
Reinforced concrete braces, level 5a-6

NBS rating: NBS 45% (IL3)
(governed by upper brace under tension)

Tension/compression failure of reinforced concrete braces.

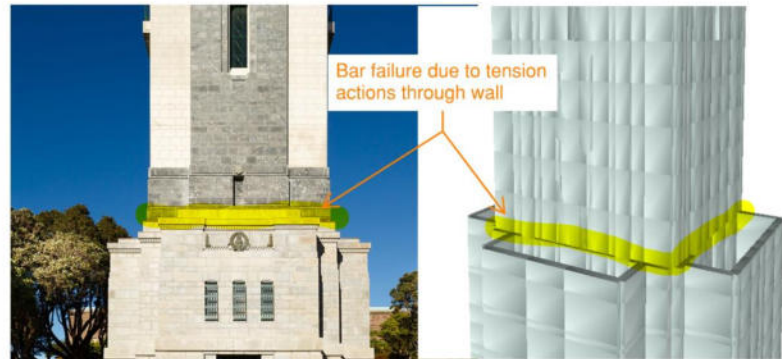
Reinforce concrete wall interface at level 3

NBS rating: 50-60% (IL3)

Bar failure due to flexural actions through wall system. At the highlighted location, the wall experiences a sharp 'kink' in flexural demand due to the localised geometry change of the tower.

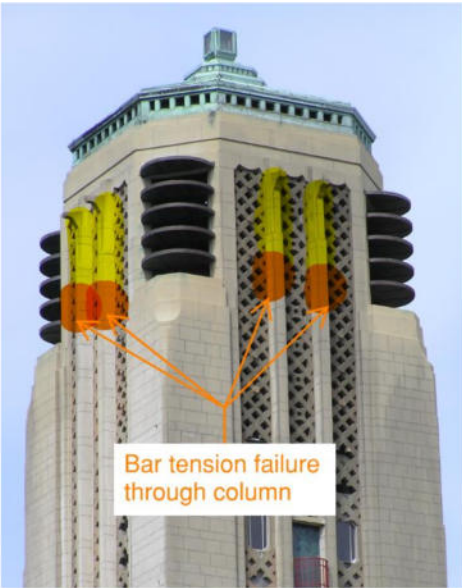
<p>Level 7b- L8 reinforced concrete centre columns</p>	<p>NBS rating: NBS 70% (IL3)</p>	<p>Bar failure under tension action on column.</p>

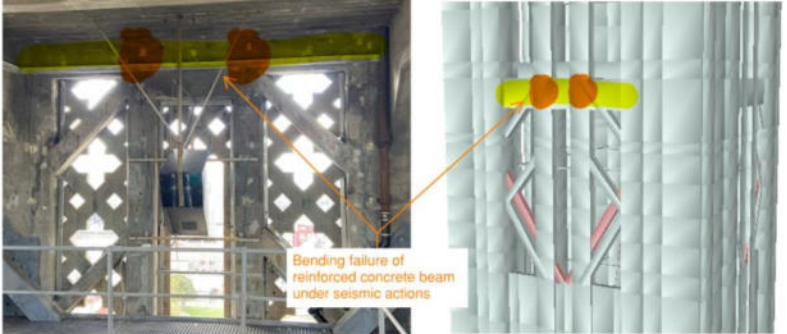
<p>Reinforced concrete edge beam, level 6</p>	<p>NBS rating: 60-70% (IL3)</p>	<p>Bending failure of reinforced concrete beam under seismic actions.</p>

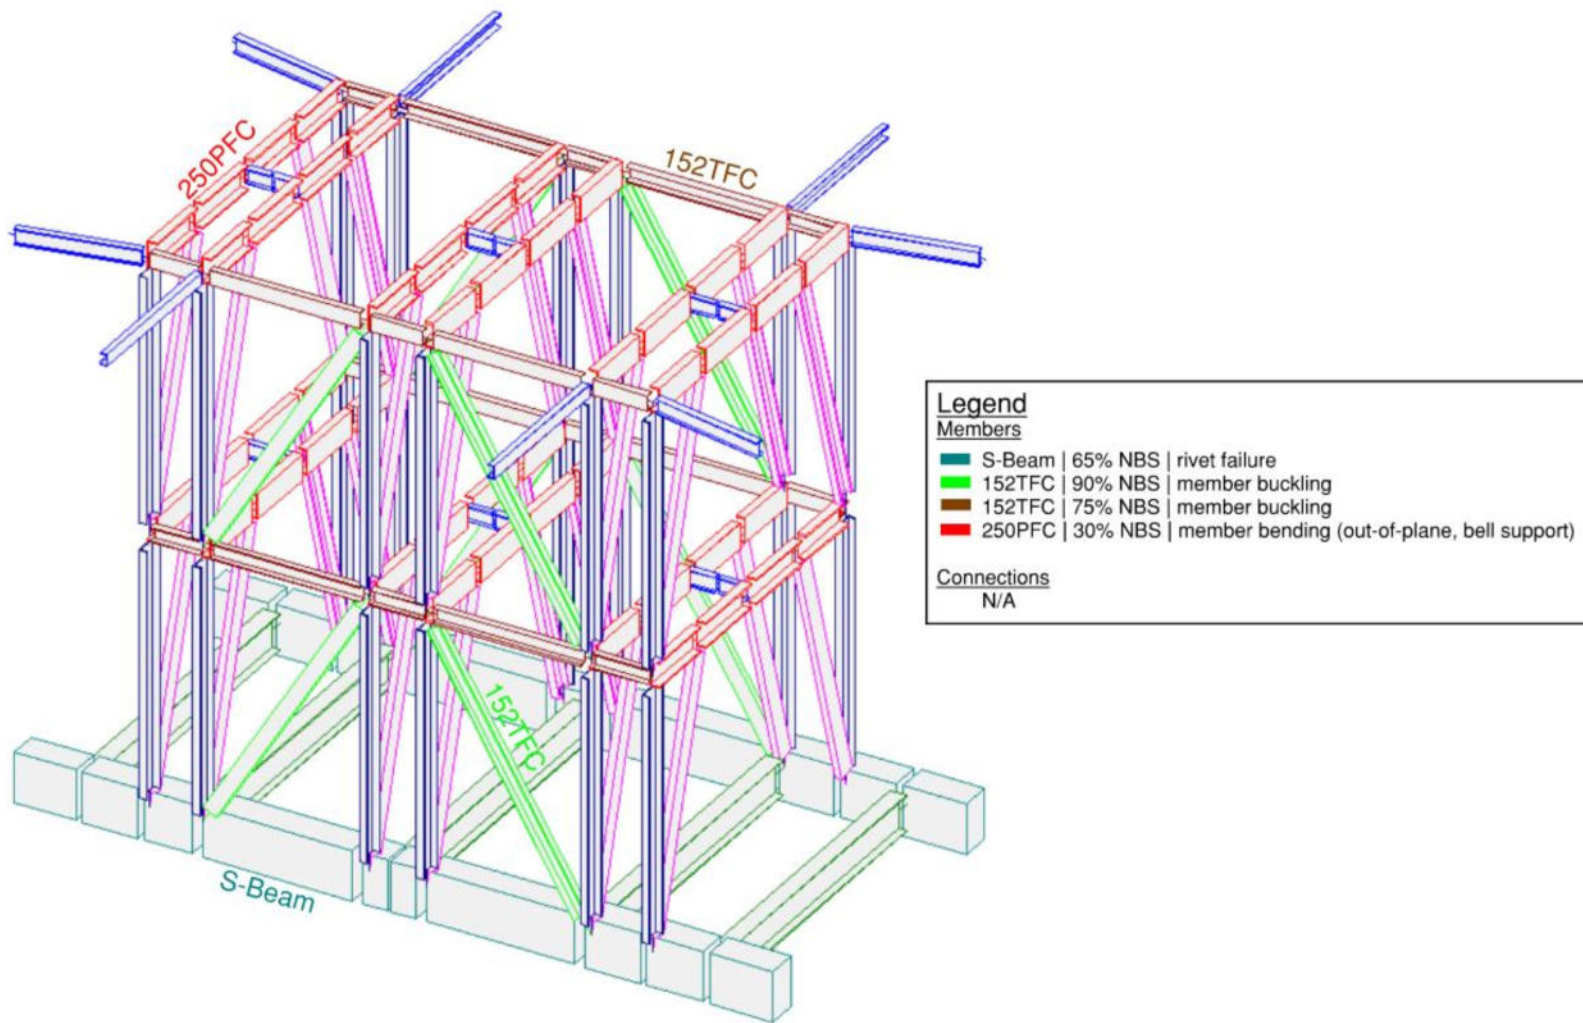
Figure 8: Lower Bell Frame - NBS Performance Summary

An explicit assessment was conducted for both the lower and upper bell frame. This included the structural integrity of the steel frames to the point at which its seismic load is delivered into the wider tower. The assessment identified several structural weaknesses in the lower and upper bell frames. These are summarised in Figure 8 and Figure 9 respectively below, where members and connections rated below 100% NBS are highlighted.

The lower and upper bell frame were both found to contain members critical to their global structural integrity which perform at levels <34% NBS. This categorises the global performance of both frames as <34% NBS.

The seismic ratings did not consider the potential local weakening of connections or members due to corrosion as it was not expected to impact the global %NBS rating of the frames. Corrosion was found to be significant within the structure. Under future strengthening of the frames, the condition of the steel along with corresponding repair or replacement is recommended to be considered.

The results of the seismic assessment of the upper and lower bell frames indicate their seismic rating to be 20%NBS (IL3) and 30%NBS (IL3) respectively, governed by local beam member failure within the frame. The failure mechanism of these steel members is ductile and occurs through excessive out-of-plane bending. Failure of these elements is expected to cause local instabilities within the bell frame. Fixity of the bells to the frame is expected to be maintained up to seismic levels >34%NBS (IL3).

Local strengthening applied to the bell frame is expected to suffice in terms of increasing the global rating of the bell frames to ≥34%NBS. Corresponding strengthening schemes which will achieve this are not outlined in this memorandum and may be requested separately.

Two alternative concept strengthening schemes are proposed for the upper and lower bell frame (appended to report): one that provides strengthening of the existing frame and another which considers the full replacement of it. Both strengthening alternatives target a 100%NBS rating (IL3).
