11 April 2023

Ministry of Culture and Heritage  
C/- The Building Intelligence Group Ltd  
PO Box 930  
Wellington 6140

**Addendum to Geotechnical Report Due to Recent Slips - Dove Myer Robinson Park, Parnell**  
**(Our Reference: 16066.000.000\_10)**

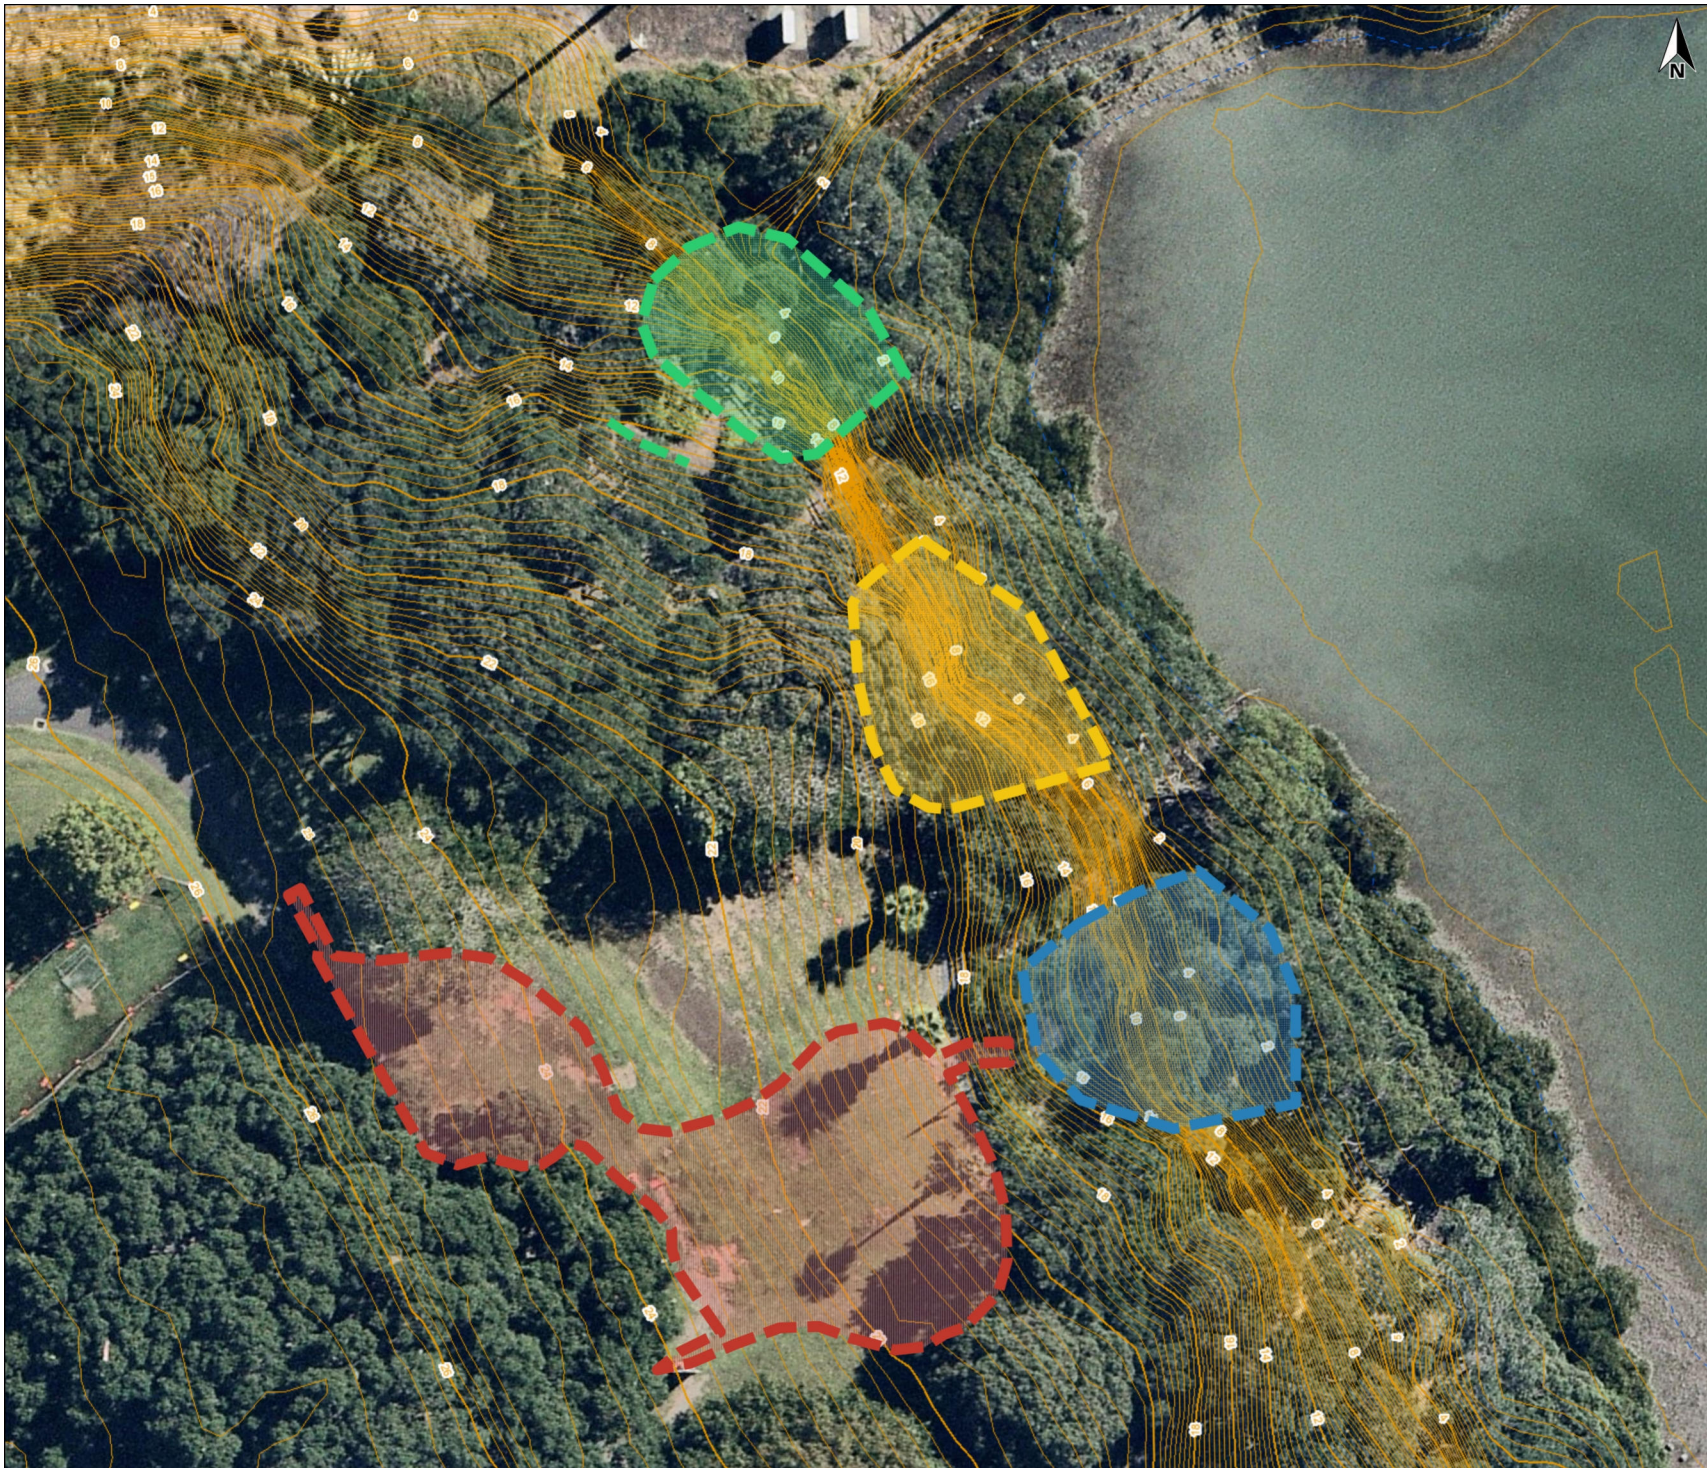
We carried out a site walkover and noticed two slips had occurred, marked as Slip 1 and Slip 2 on the attached plan (Appendix 1). We also noted tension cracks above the path further to the north, marked as Slip 3 on the attached plan.

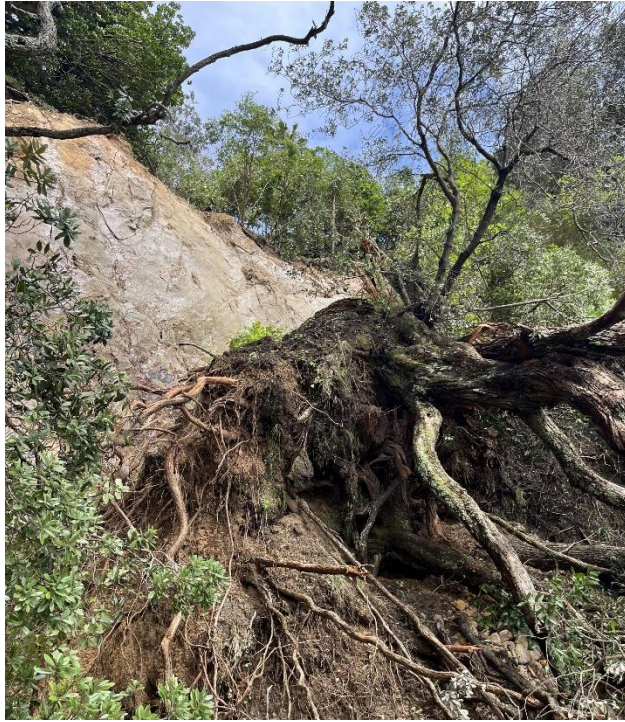
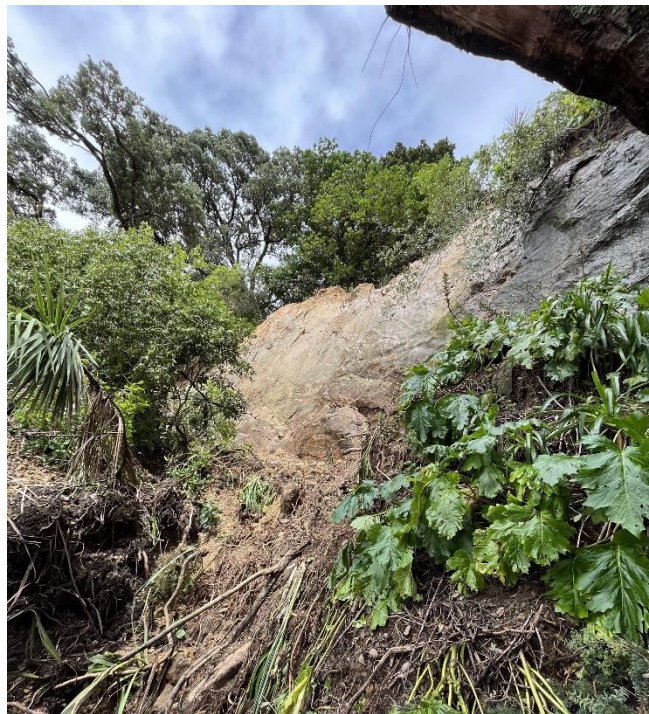
This slip appears to be associated with a large tree losing support and toppling from the cliff. It has brought its root system (and associated soil) down the face of the cliff and stripped the vegetation off the cliff face.

- The thickness of the upper soil profile couldn't be readily confirmed.
- The rock portion of the cliff face appears to have regressed less than 1 m (horizontally) based on thickness of soil / root mass adjacent to the slip.
- No visual observations could be made regarding the slip within the soil profile due to it being located within the bush area and it being unsafe to access.

Slip 1 – Taken from base of slip

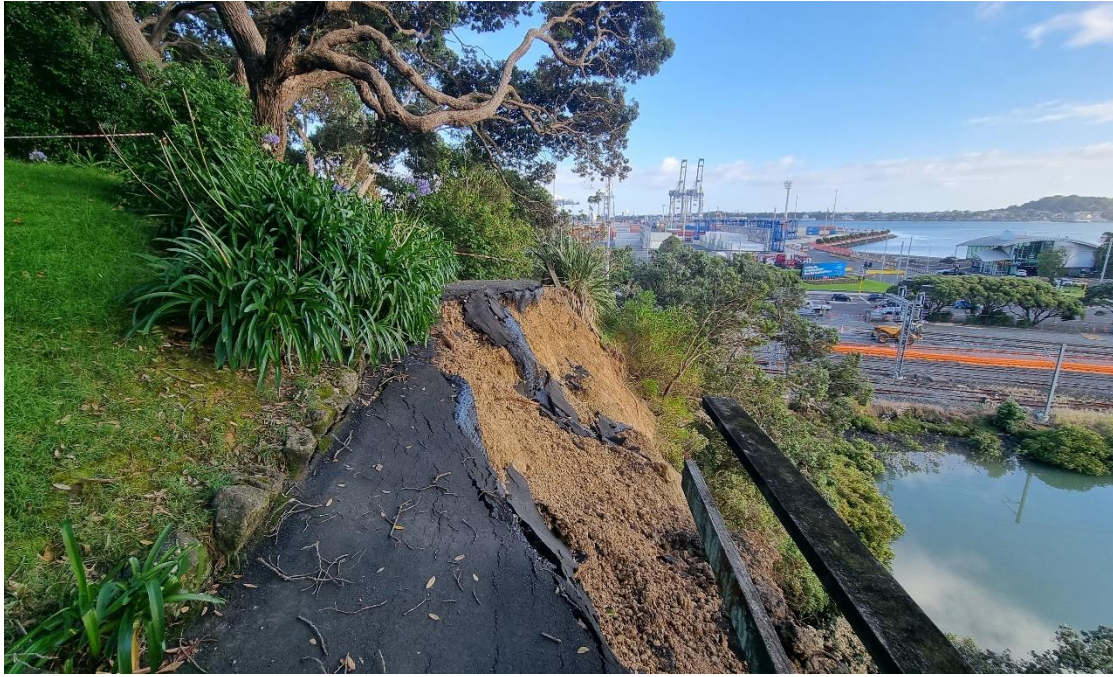
This slip was likely the result of excess surface water travelling along the path and concentrated flow onto the cliff.

- The upper soil profile is approximately 2-3 m thick.
- The rock portion of the cliff face appears to have regressed less than 1 m (horizontally) based on thickness of soil / root mass adjacent to the slip.
- The upper soil portion of the cliff face appears to have regressed back approximately 2 m from the pre-slip crest (which is assumed to have been just beyond the path based on the adjacent cliff line).

Slip 2 – Taken from top of slip

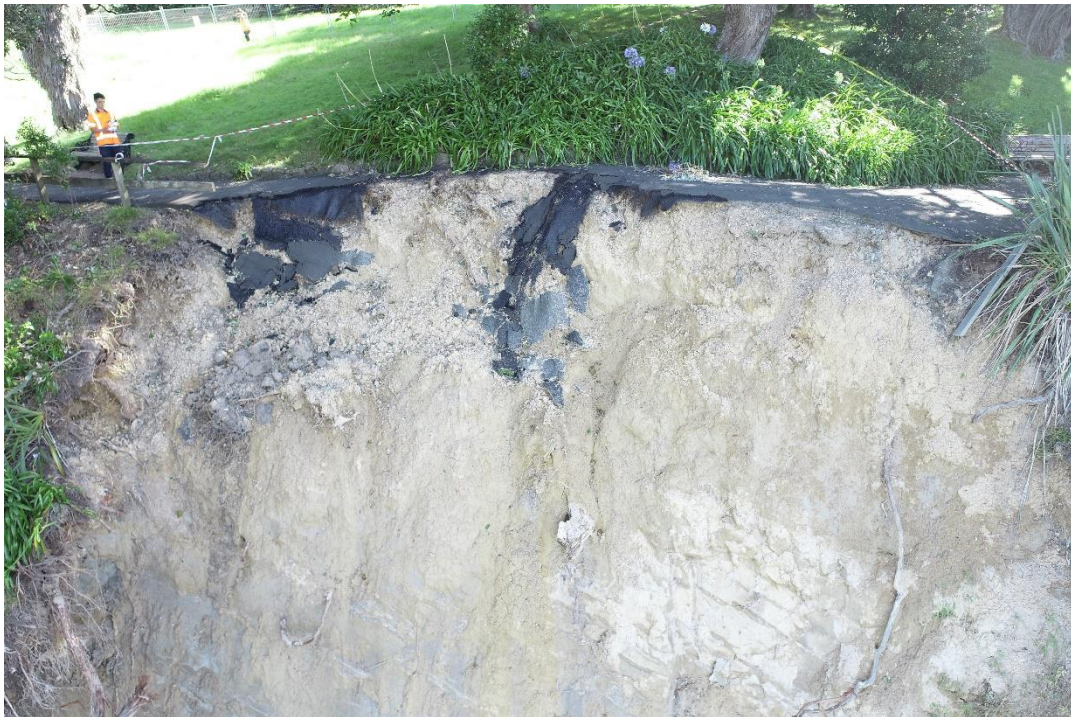
Slip 2 – Drone Footage showing exposed face

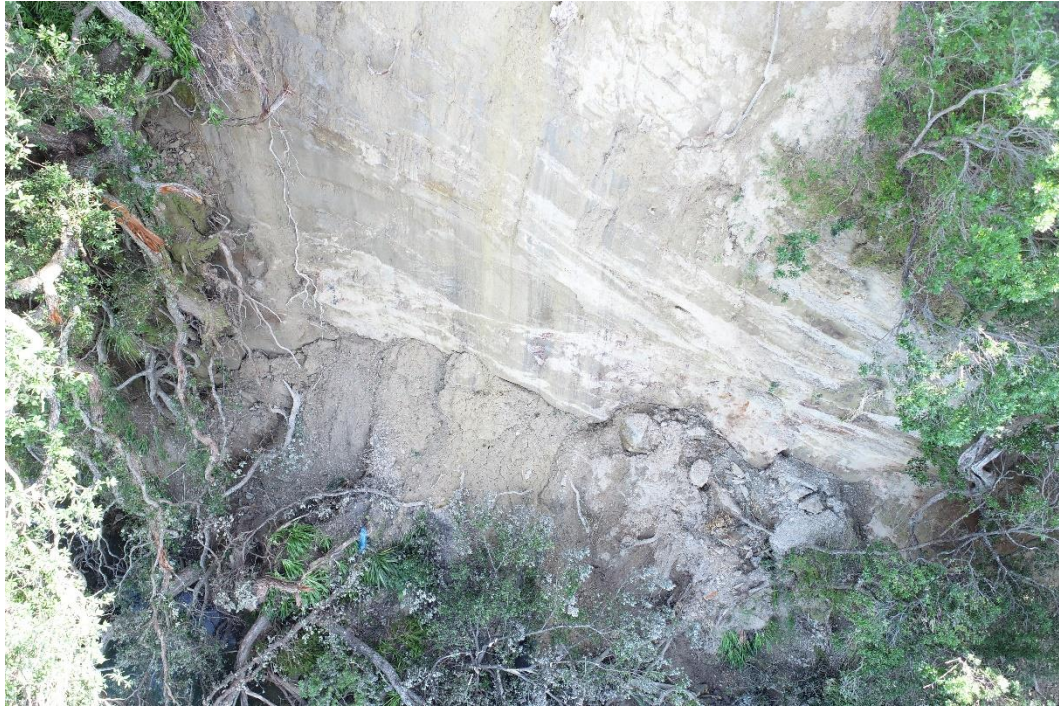
Slip 2 – Drone footage showing adjacent growth (for depth of slip) and debris

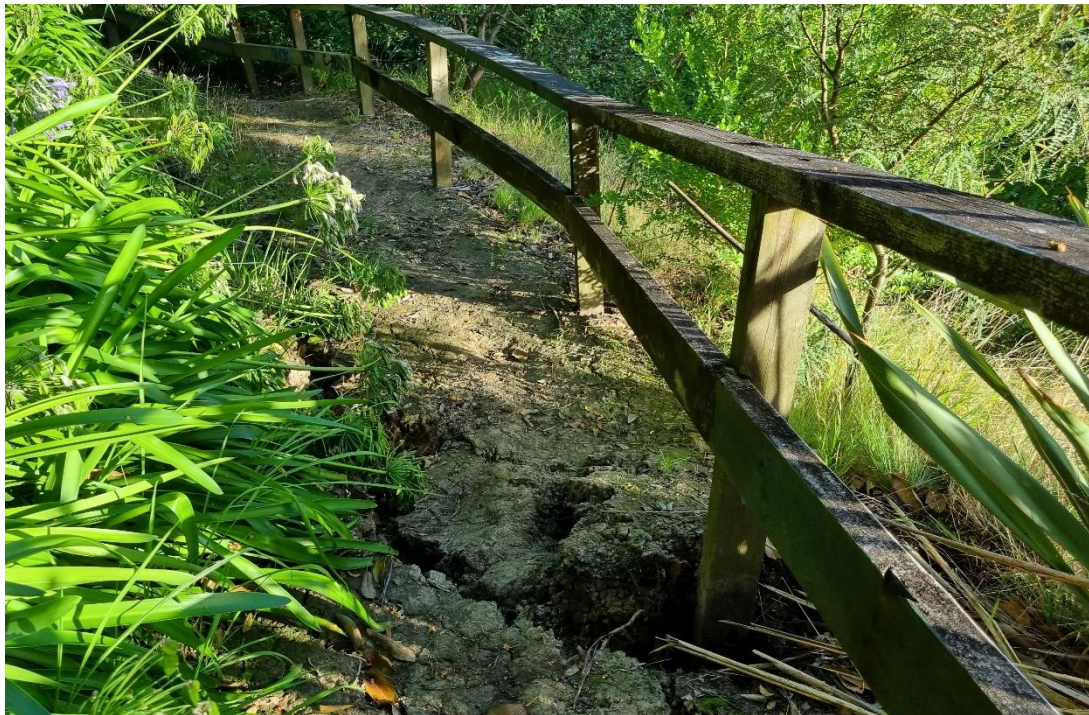
We noted that a third slip (Slip 3) had occurred where the tension cracks had been observed on 9 February.

Slip 3 – Tension cracks on 9 February (prior to slip)

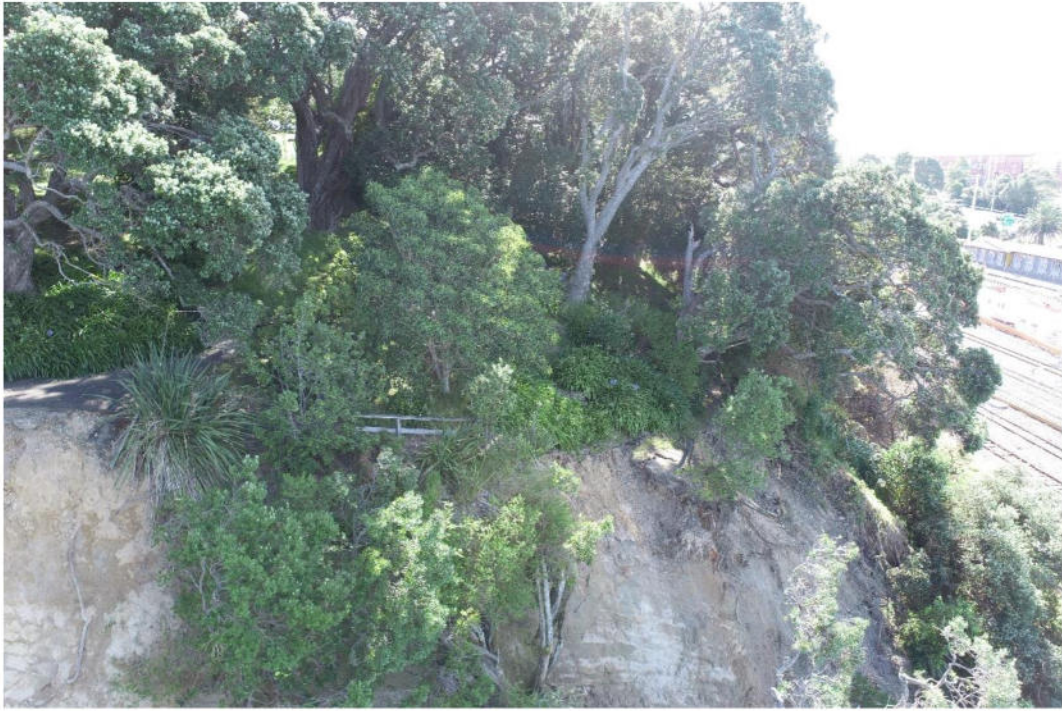
This slip appeared to have been the result of excess surface water travelling along the path and concentrated flow onto the cliff and into tension cracks (which had likely formed in association with the first storm events).

- The upper soil profile is approximately 2-3 m thick.
- The rock portion of the cliff face appears to have regressed less than 1-2 m (horizontally).
- The upper soil portion of the cliff face appears to have regressed back 2-3 m from the pre-slip crest (which is assumed to have been just beyond the path / handrail based on the adjacent cliff line).

Slip 3 – Drone Footage

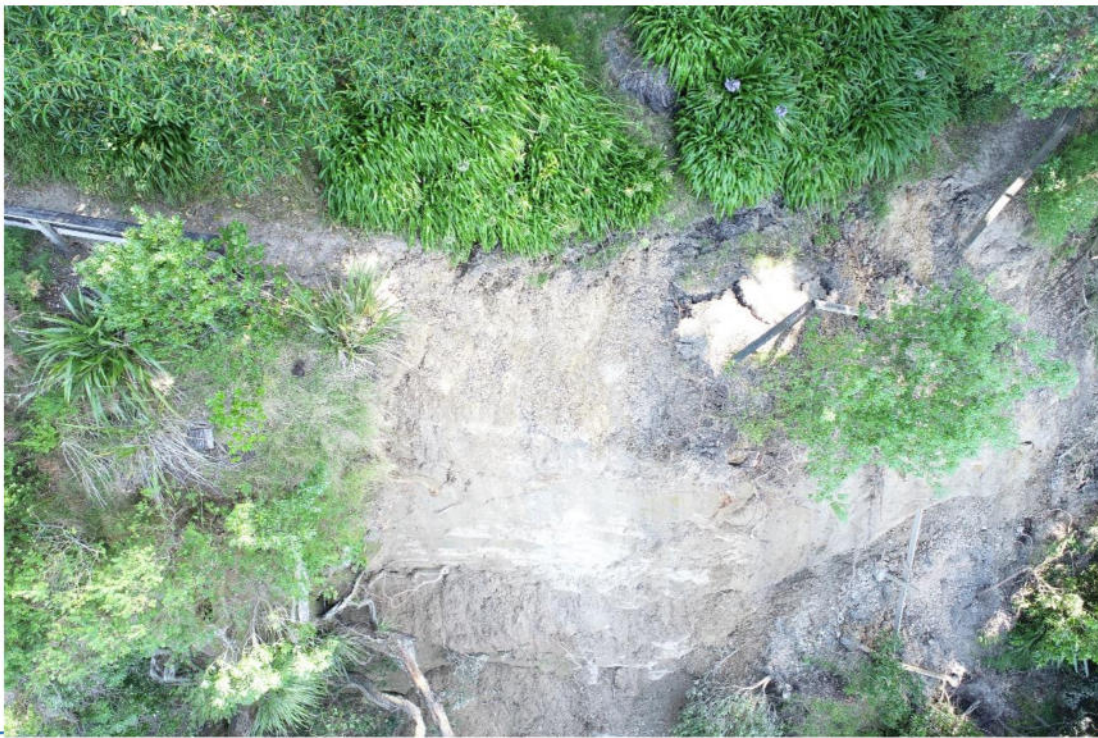
Slip 3 – Drone Birds Eye View

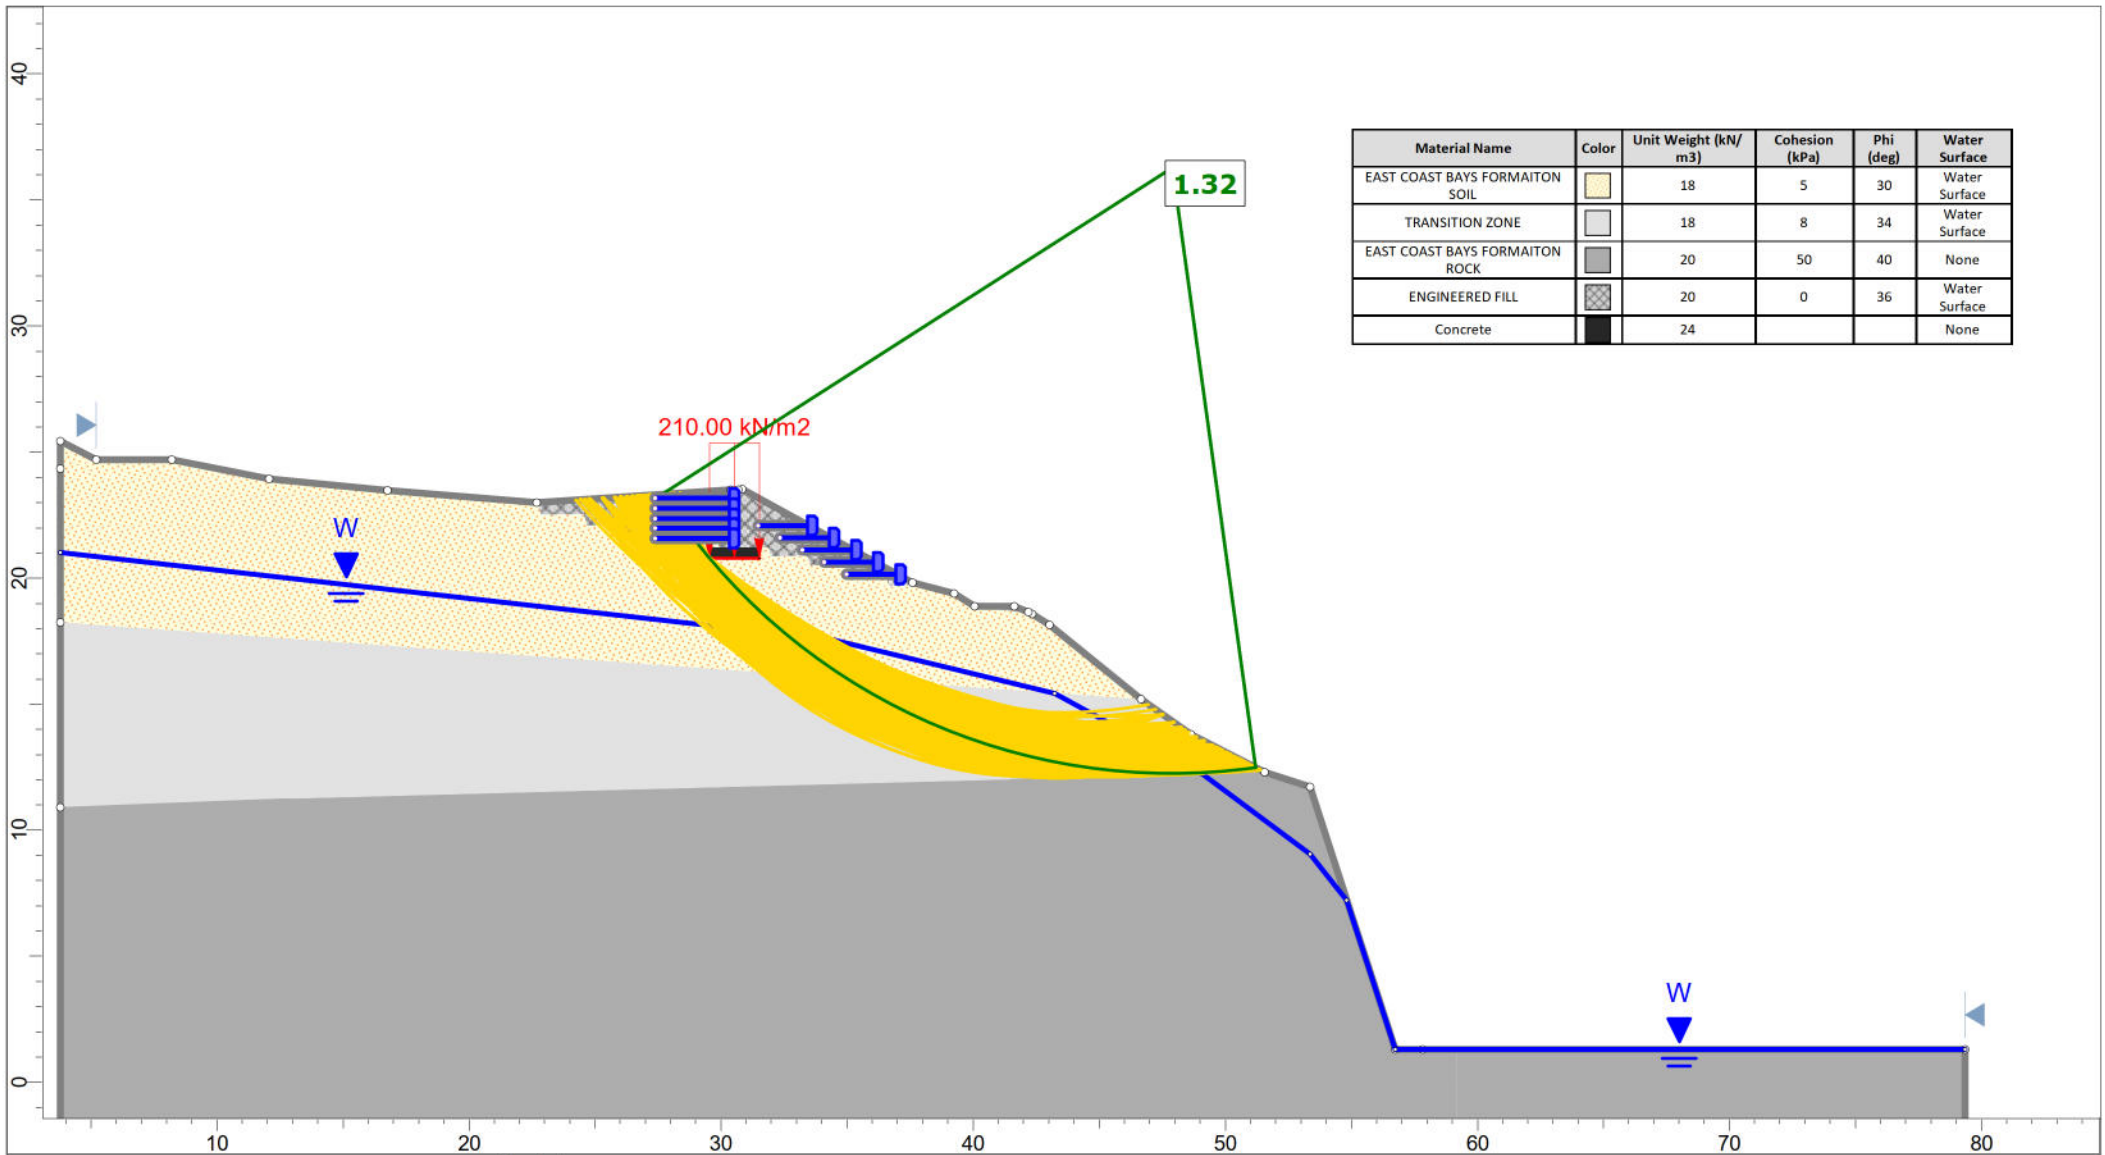
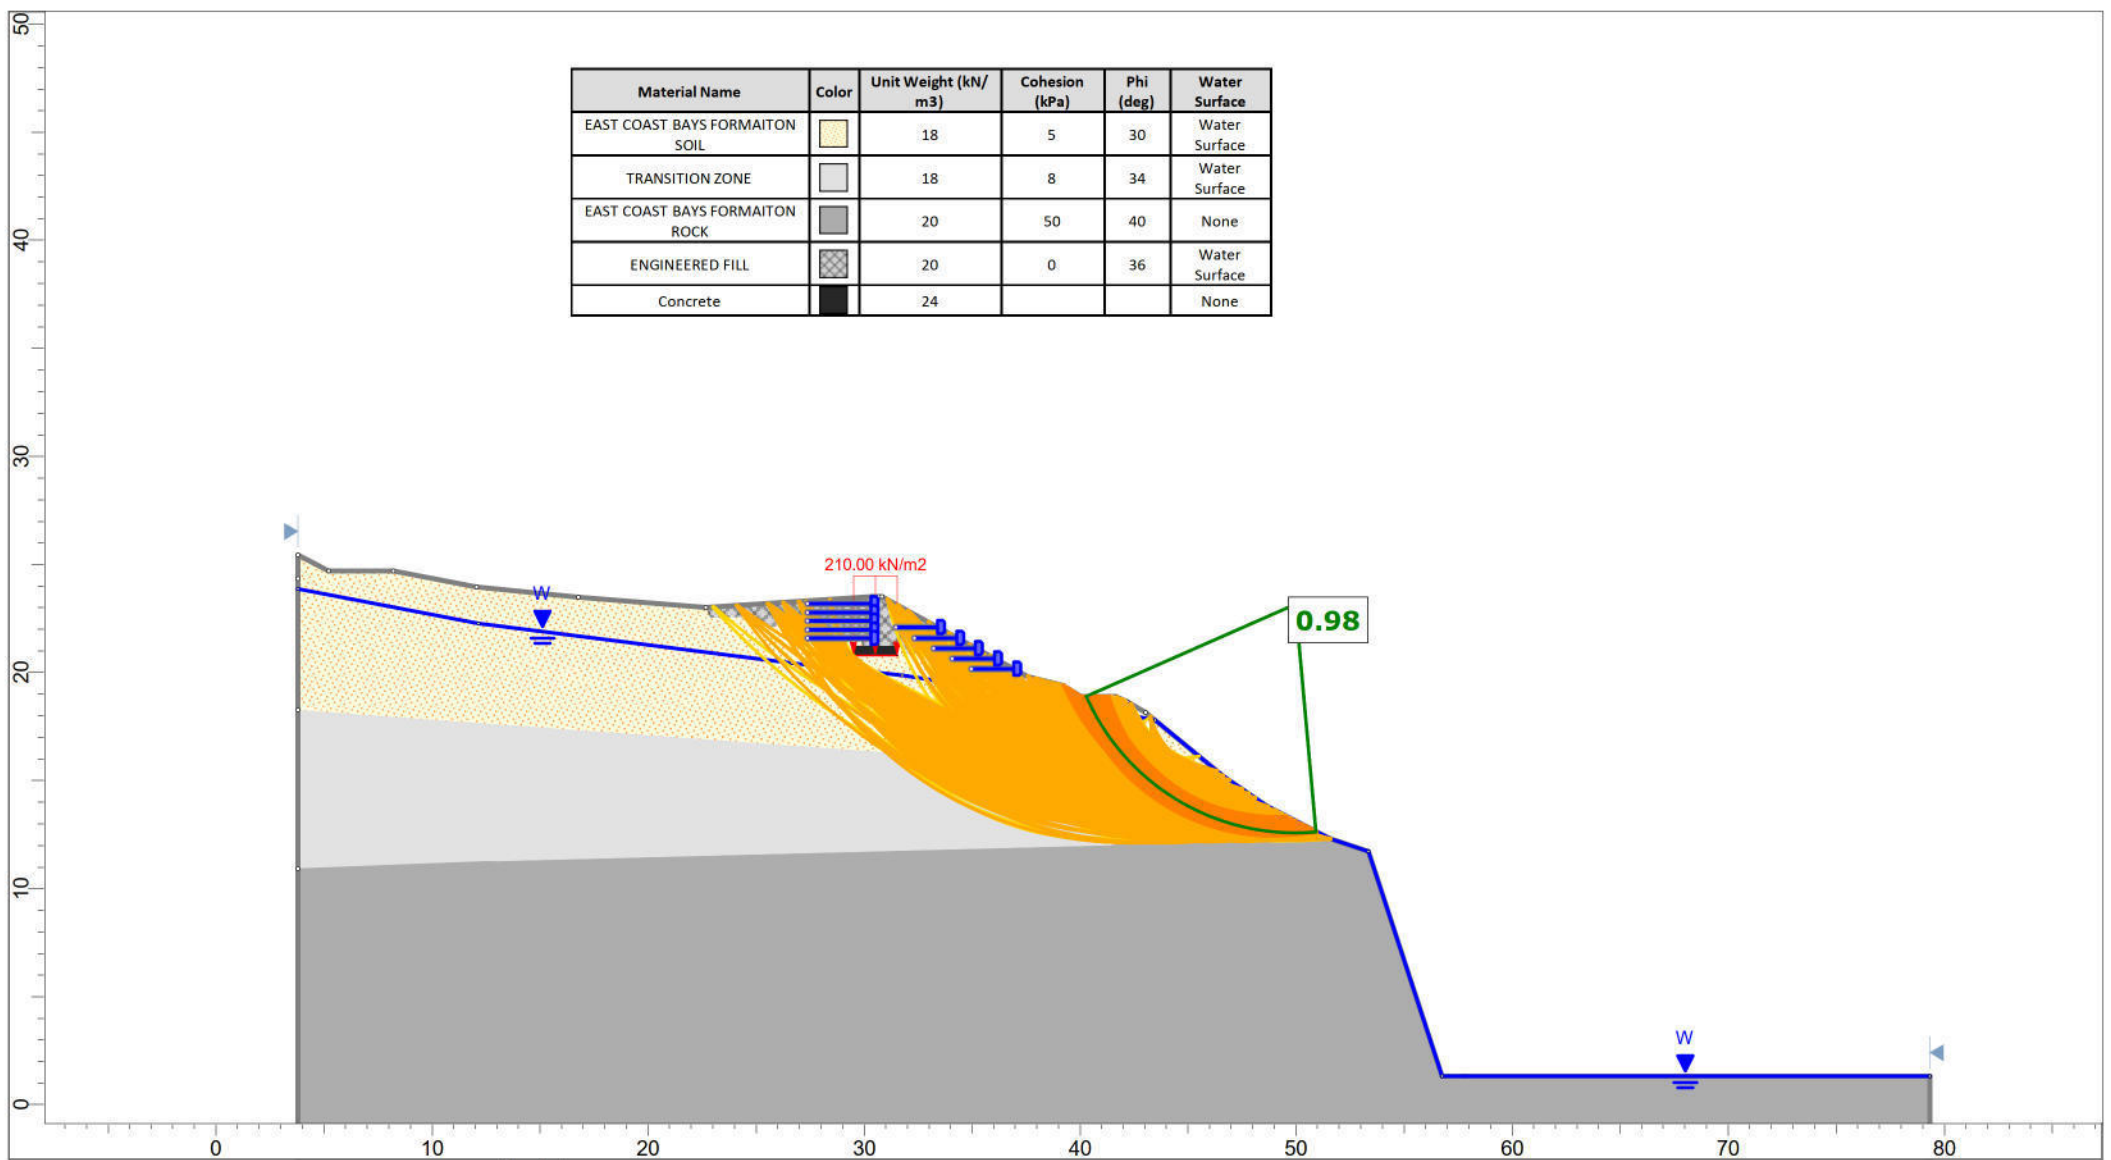
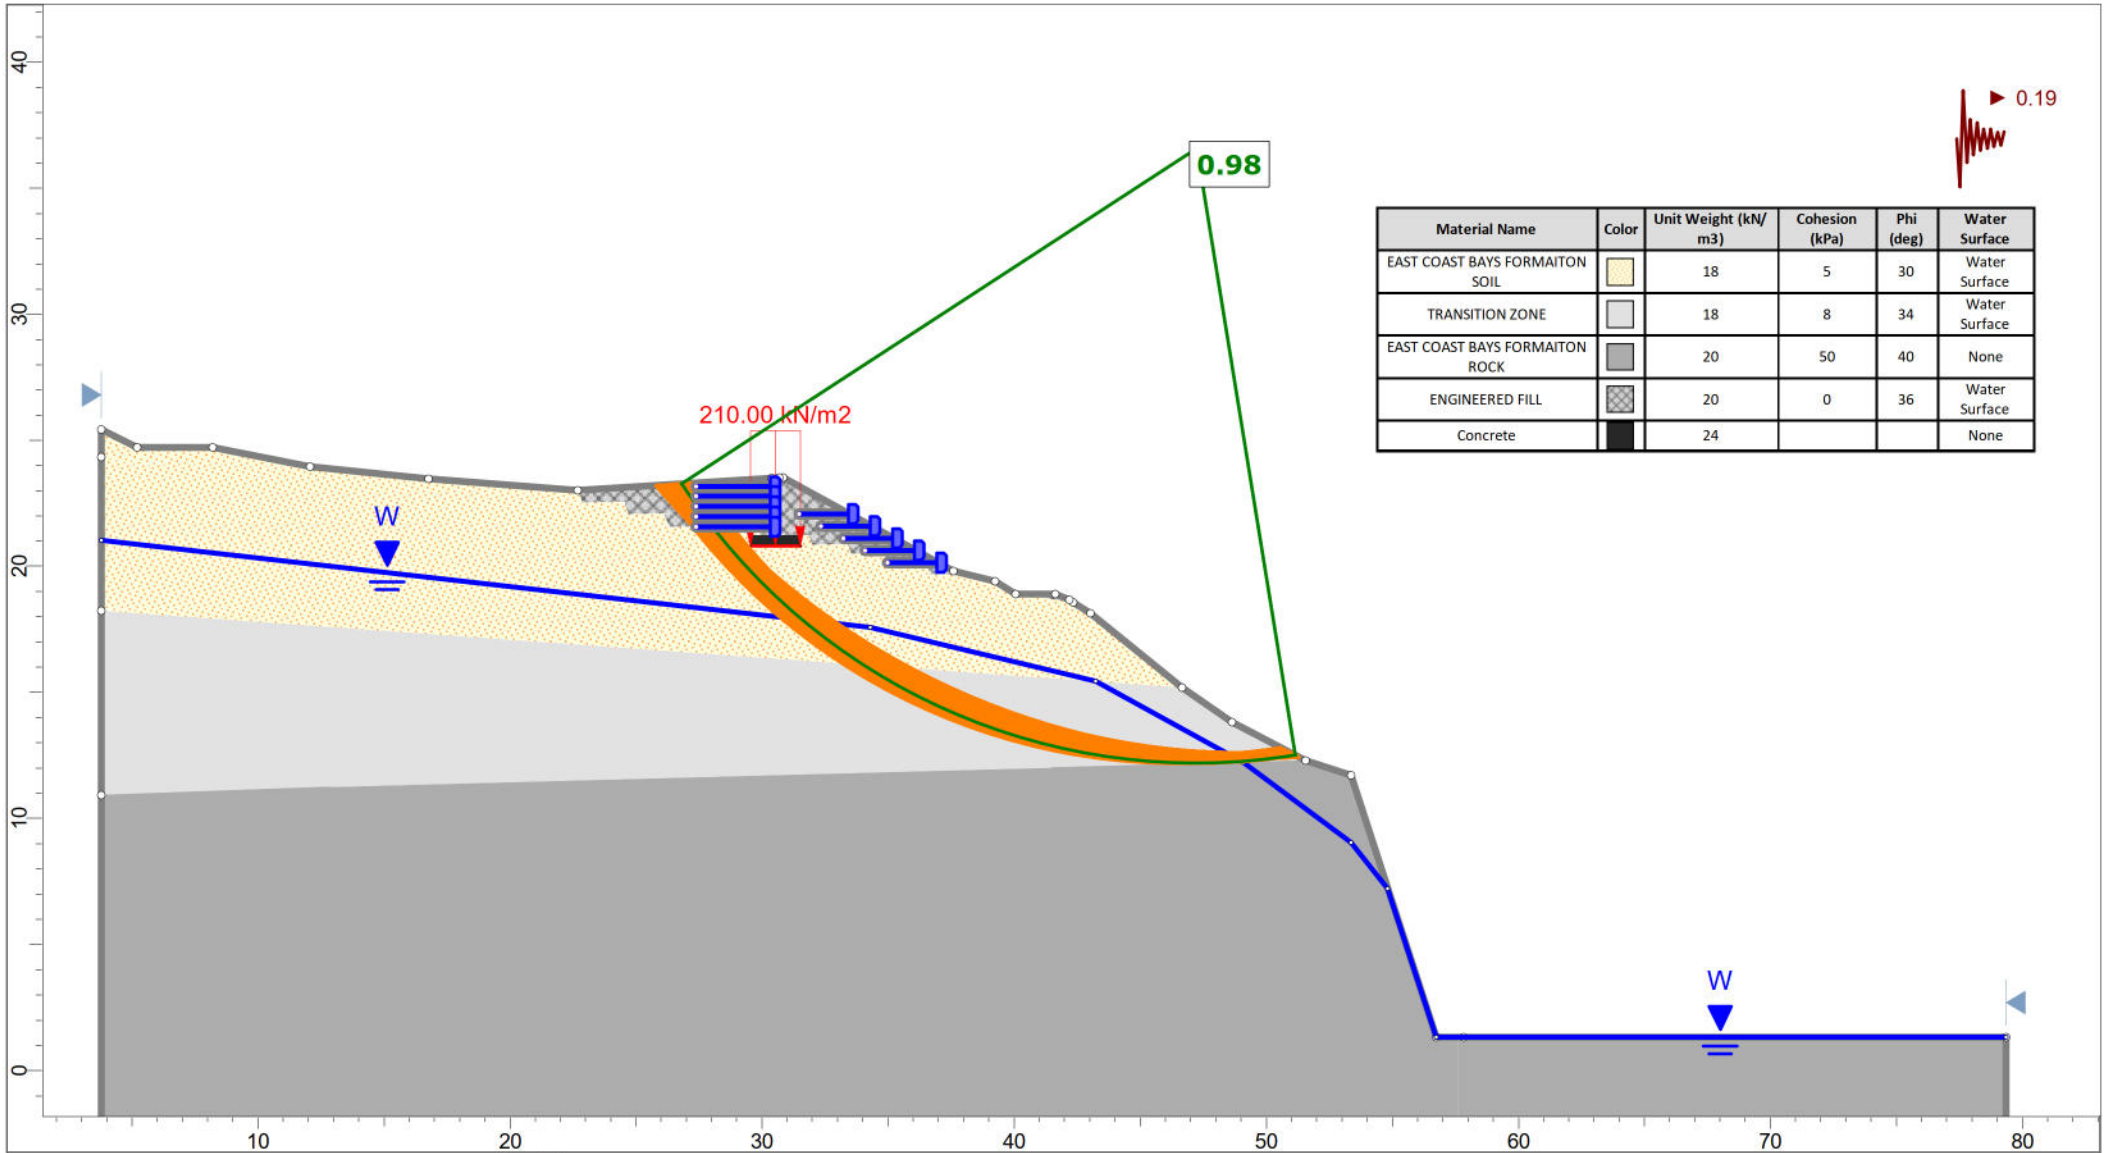
The results of the reassessment are presented in Table 1 below and detailed outputs are included in Appendix 3. The proposed development and surrounding ground (taking into account the recent slip and the increased design life) no longer achieves adequate factors of safety against instability.

To achieve adequate factors of safety for the proposed Erebus Memorial and the surrounding land we would recommend that a palisade wall be installed downslope of the structure. The palisade wall will likely involve large diameter reinforced concrete piles extending 5 m to 10 m into rock at close centres. It may also require tie back anchors and a capping beam at the ground surface to limit wall deflections.
