11 April 2023

Ministry of Culture and Heritage  
C/- The Building Intelligence Group Ltd  
PO Box 930  
Wellington 6140

**Addendum to Geotechnical Report Due to Recent Slips - Dove Myer Robinson Park, Parnell**  
**(Our Reference: 16066.000.000\_10)**

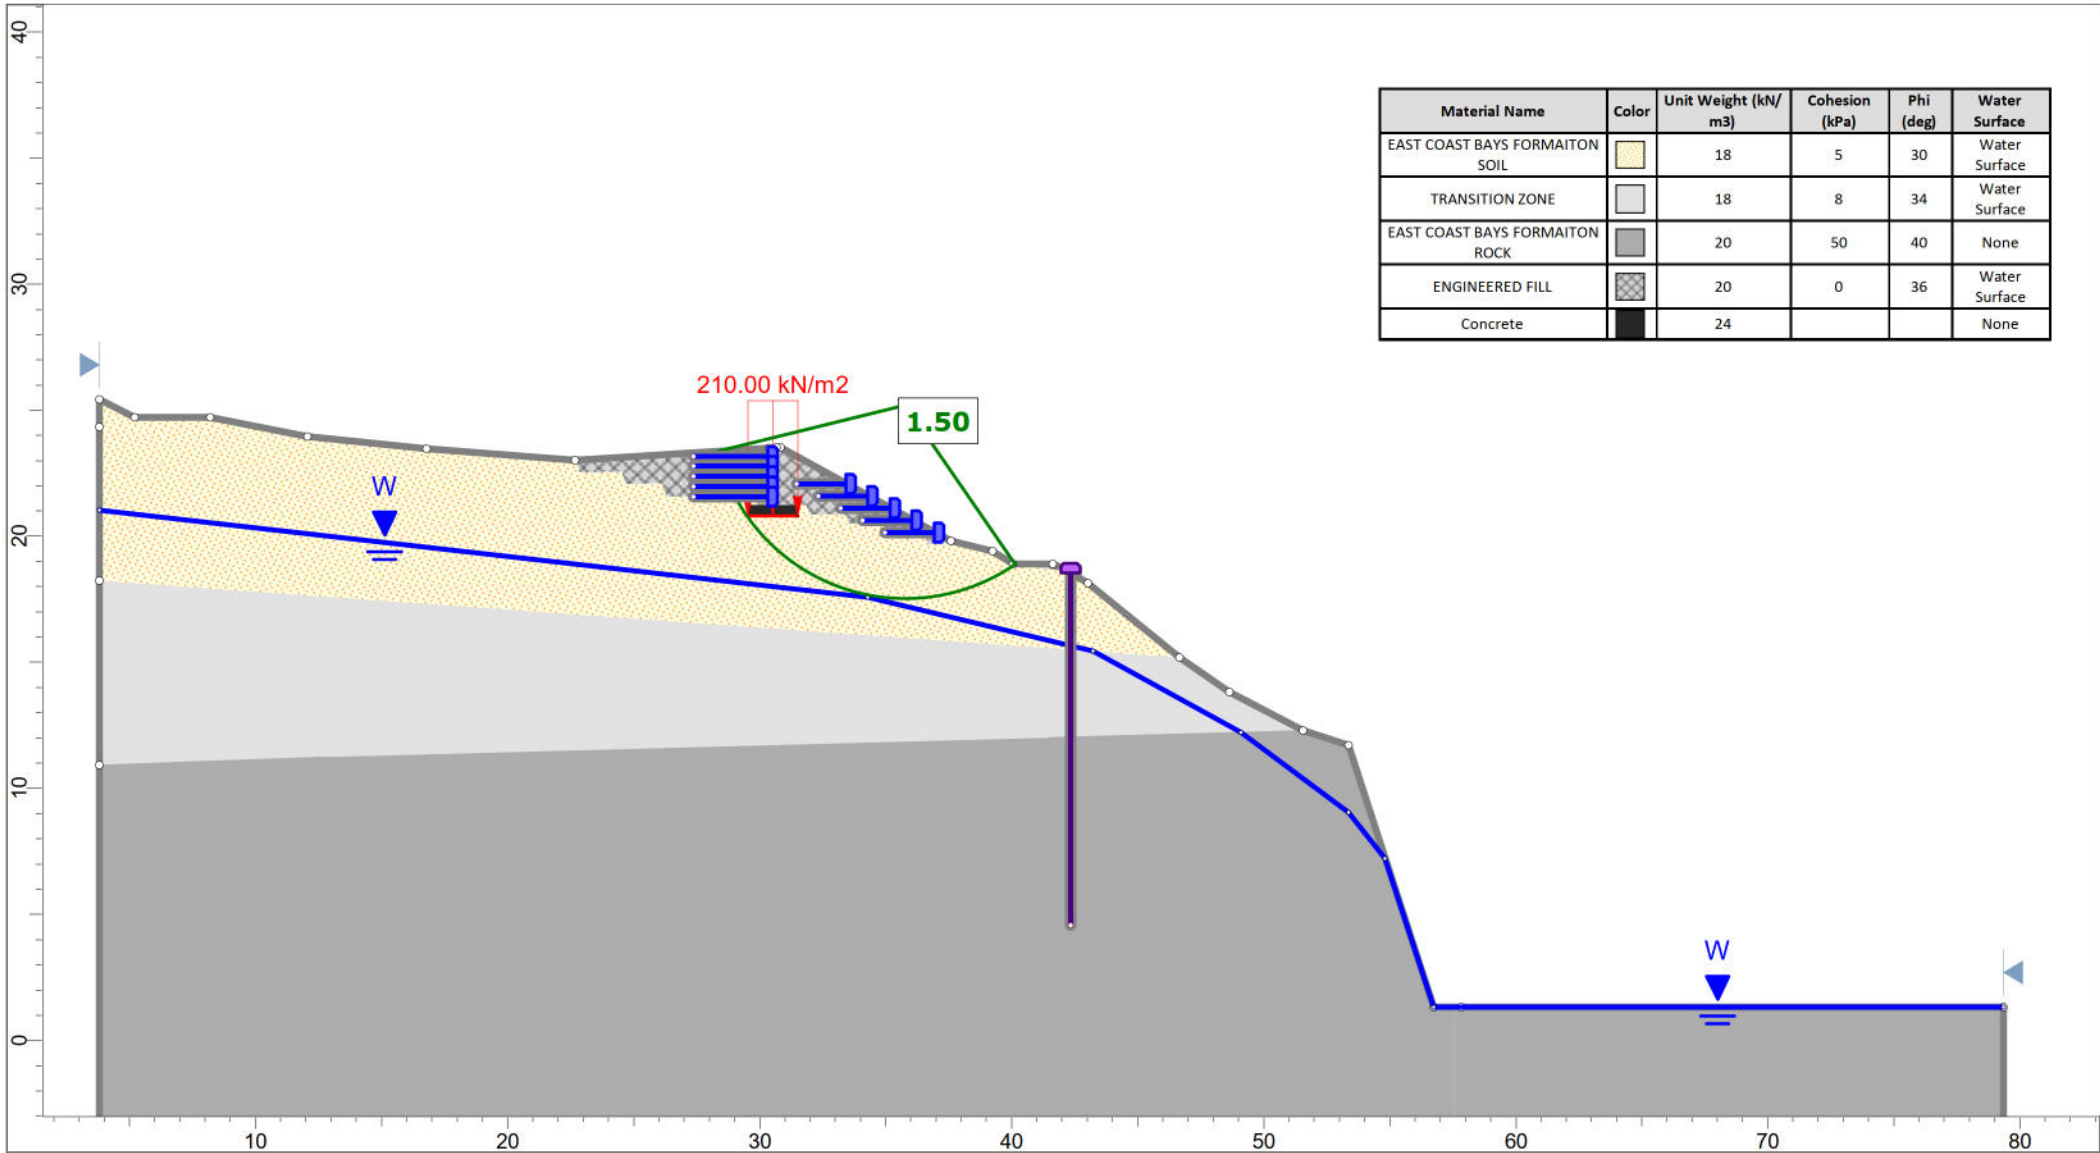
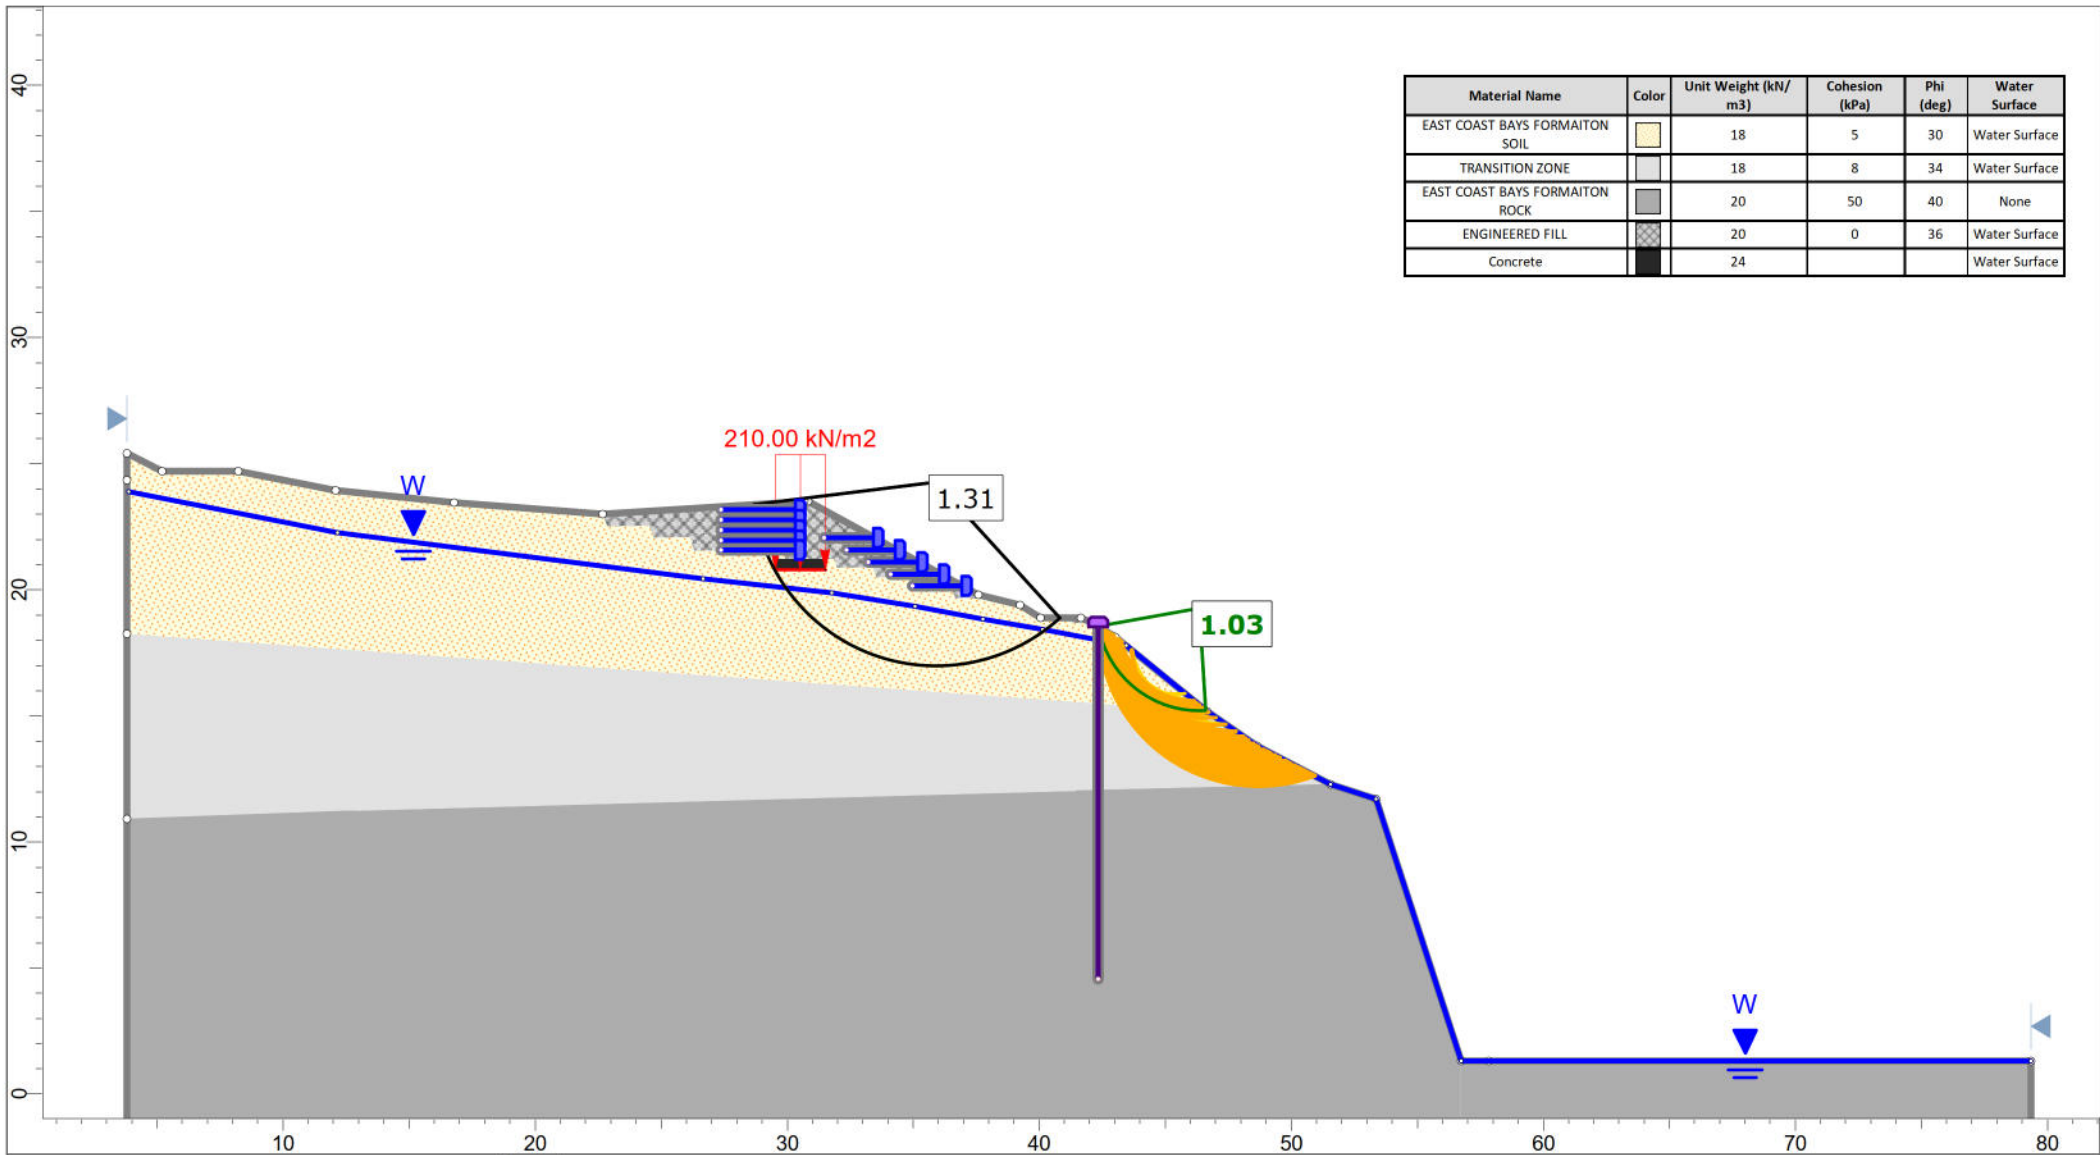
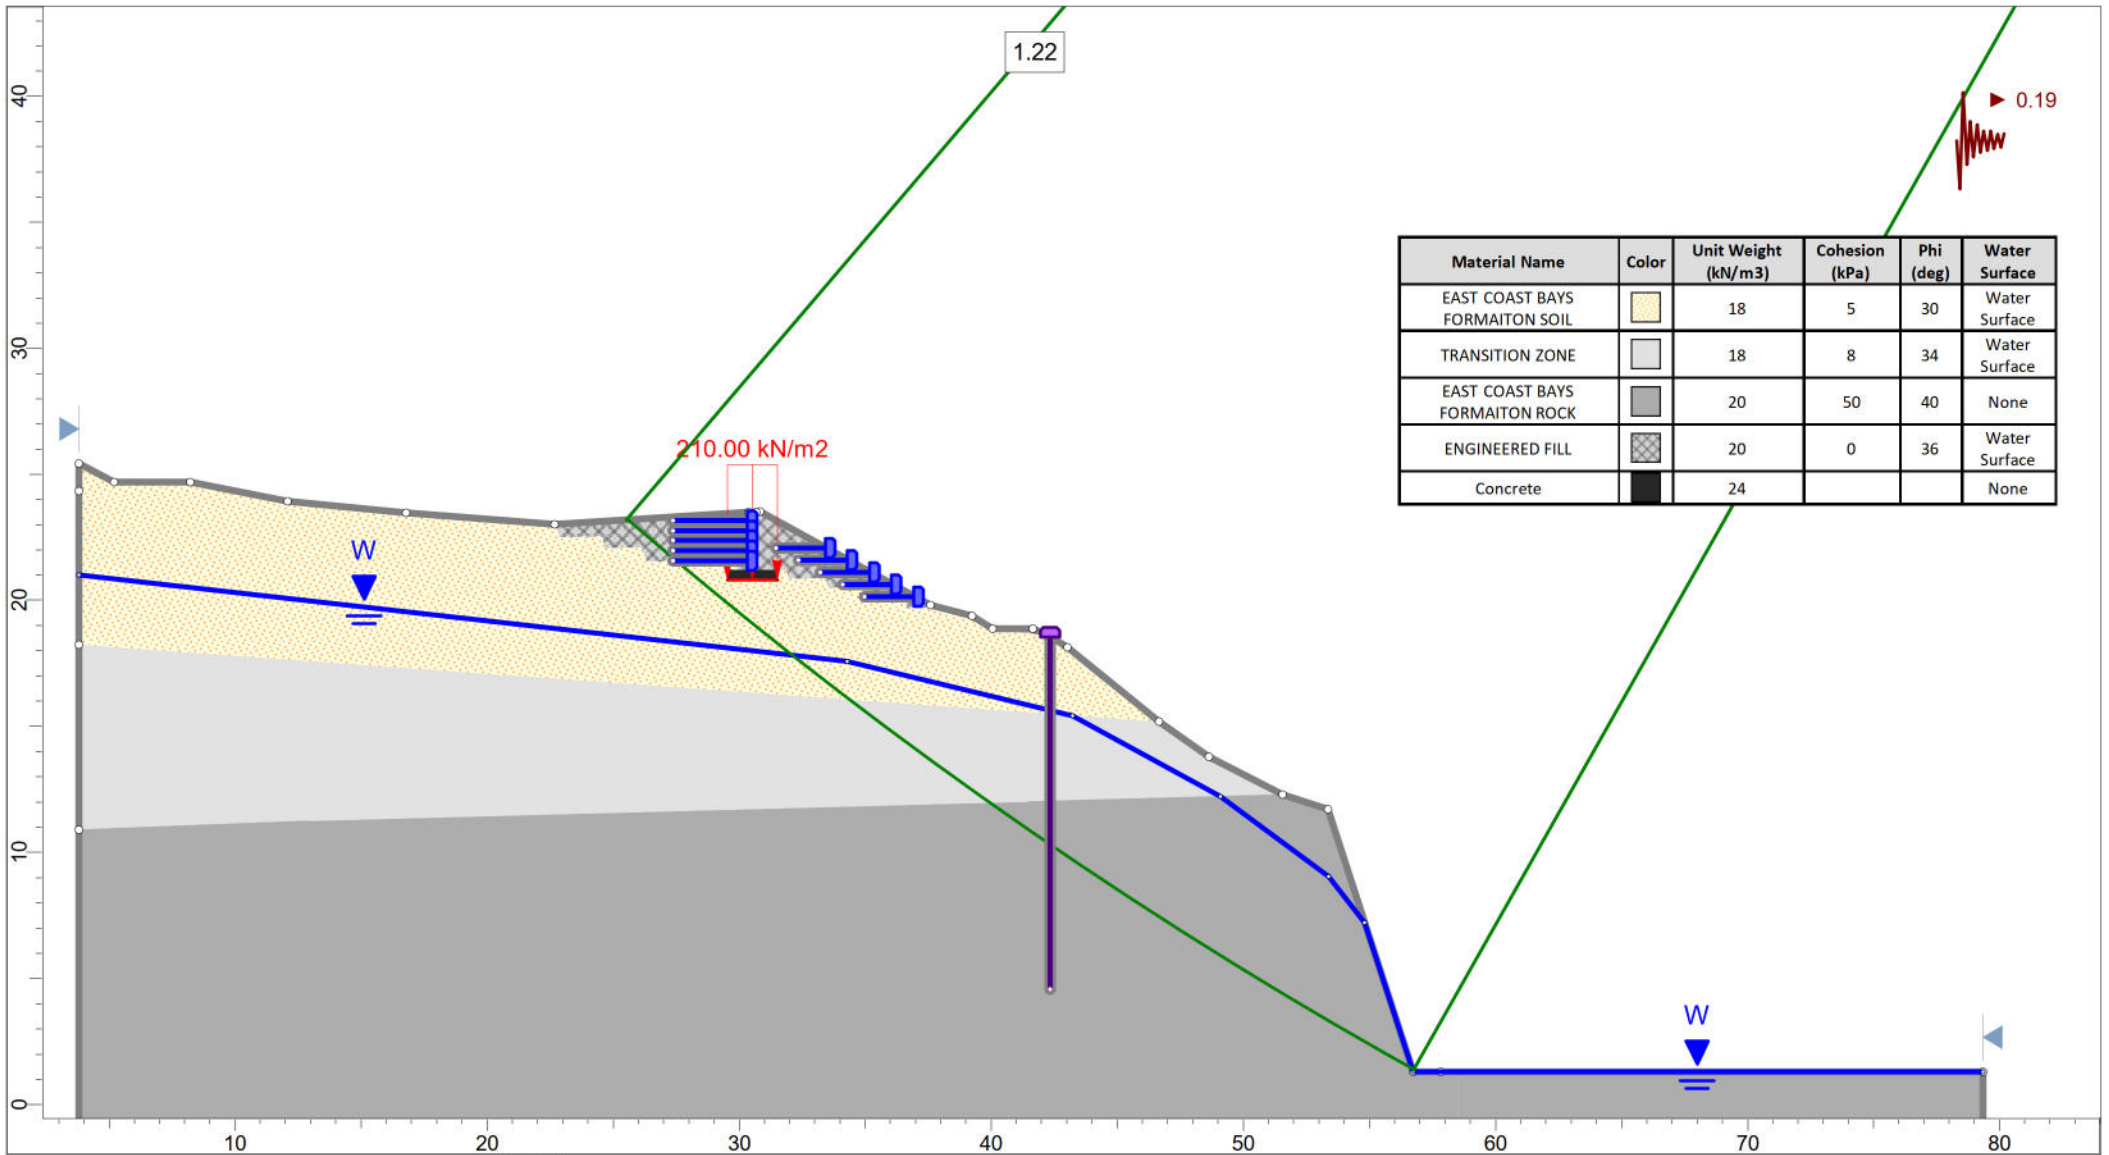
We have therefore run a second case which includes a palisade wall along the downslope extent of the proposed development. With this wall installed, the factors of safety increase to above the minimum values currently required by Auckland Council.

2 – Factor of safety in brackets is downslope of the palisade wall, indicating that slips may still occur downslope of the wall however the land upslope of the wall will have adequate factors of safety against instability.

To achieve adequate factors of safety for the proposed Erebus Memorial and the surrounding land we would recommend that a palisade wall be installed downslope of the structure. The palisade wall will likely involve large diameter reinforced concrete piles extending 5 m to 10 m into rock at close centres. It may also require tie back anchors and a capping beam at the ground surface to limit wall deflections.
