# Ministry for Culture and Heritage National War Museum - Carillon Tower STR

## Design Features Report

Version 1  
01 March 2024  
144373.13

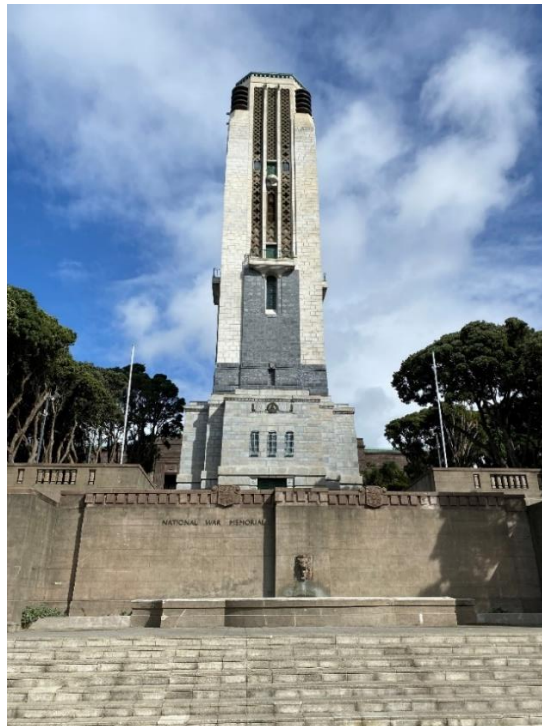
Figure 1: Photograph of the National War Memorial Carillon Tower
